Client: 23247A Timberlake Water System

Comp # : 901 Well Pump/Motor #3 - Replace

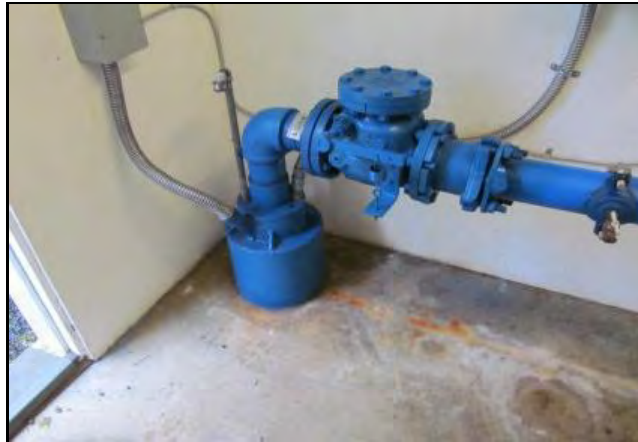
Quantity: (1) 30 HP submersible 8"

Location : 150' SE of Well #1

History : Reportedly replaced last in 2008

Evaluation : As already mentioned, this well has been online since 2008; typical service life assumed below for pump / motor.
Track actual expenses and timing of all significant components to help ensure accurate budget forecasting for your community.

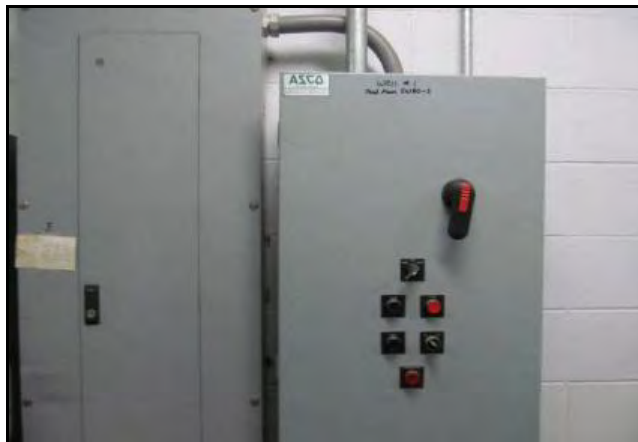
Comp # : 904 Well #1 Control - Replace

Evaluation : As already mentioned Well #1 has reduced capacity and is now considered an additional point of withdrawal. Regardless, long term planning dictates assumption for eventual intervals of controller replacement to ensure functionality and offset potential parts obsolescence.

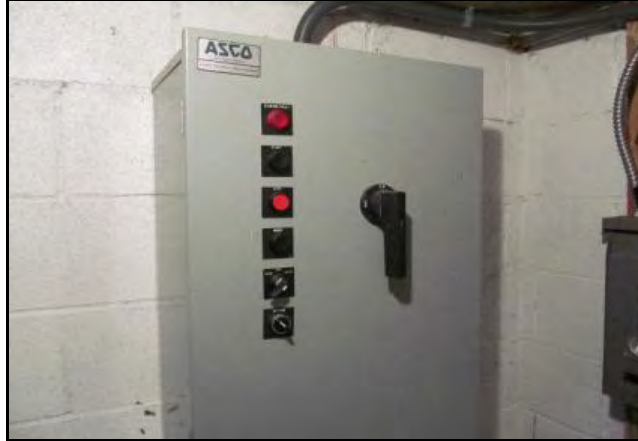
Comp # : 904 **Well #2 Control - Replace** Quantity: (1) motor control

Evaluation : Well was installed in 1971, controller was replaced last in 2004 project. No reported problems.

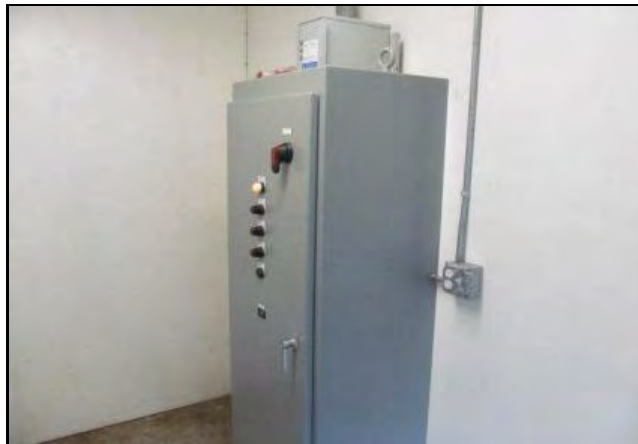
Comp # : 904 **Well #3 Control - Replace** Quantity: (1) motor control

Evaluation : Installation in 2001; usage since 2008 reported. Cycles of replacement are factored below.

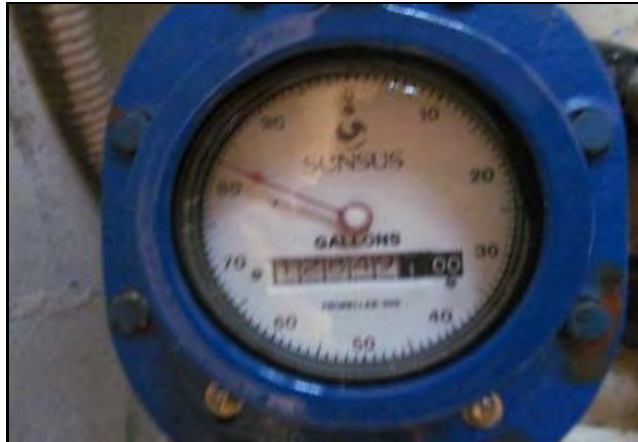
Comp # : 905 **Source Flow Meters - Replace** Quantity: (3) source meters

Evaluation : No reported problems; ages and types vary. History of replacement includes maintenance staff replacing meter for Well #2 in 2011 (parts expense was \$1,200). Typical life is in the 5-10 year range. Expense of individual replacements when needed does not merit reserve designation.

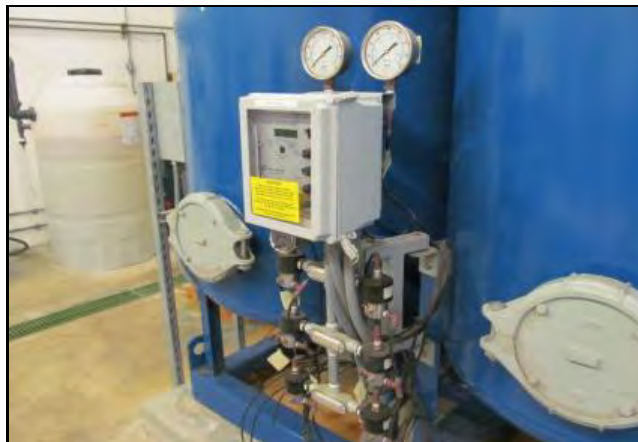
Comp # : 907 **Filter System - Maintain/Replace** Quantity: (6) tank system

Evaluation : Raw water is directed from wells to this ATEC commercial system which utilizes pyrolusite media to remove iron, manganese and control odor; installed in 2005 as part of \$352,000 project (segregated portion ~\$80,000). No reported problems at present. Assuming proactive maintenance continues, anticipate 30-40 year replacement cycles of equipment factored below for planning purposes. Note; if significant needs or patterns of media replacement interval / expense develop in the future, incorporate in future reserve updates as conditions merit.

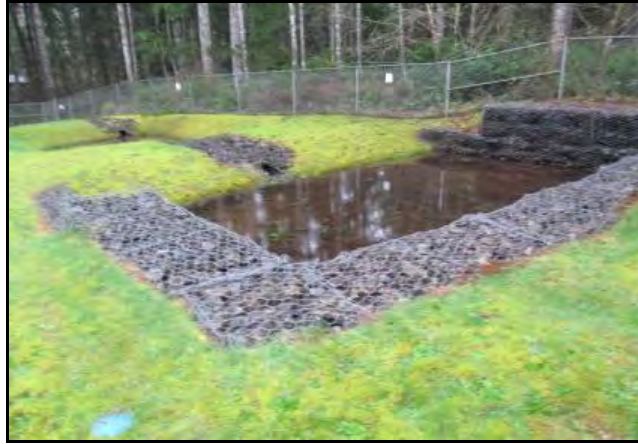
Comp # : 908 **Backwash Infiltration Pond-Maintain** Quantity: Extensive square feet

Evaluation : No reported problems or previous repair history. After filtration, automatic individual tank back flushing occurs with discharge into this infiltration pond. No predictable expectation of significant expense meriting reserve designation.

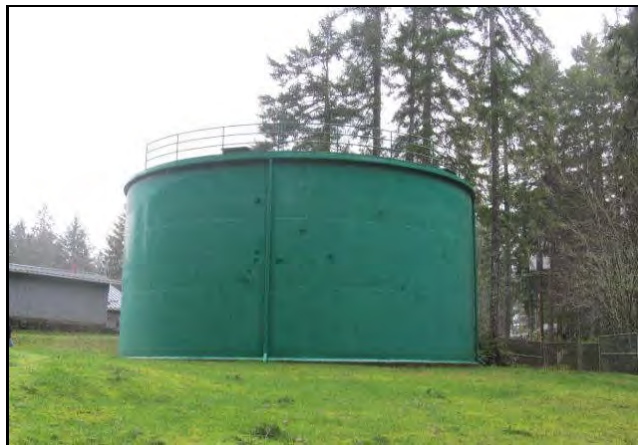
Comp # : 910 Storage Tank, Steel - Replace Quantity: (1) 200,000 gallon

Evaluation : Filtered water next enters this steel storage tank which was installed in 1995 at an expense of roughly \$300,000; interior was refurbished in 2012 at an expense of \$112,000. The tank was blasted and then coated on the interior with an industrial epoxy system by HCl Industrial and Marine Coatings; this was the first interior coating since original. Exterior finish is faded and also has some local damage and corrosion due to vandalism; no bids or definitive timeline for exterior recoating was expressed. Assuming proactive maintenance typical industry life expectancy for steel storage tanks is between 40 and 50 years. Installation of cathodic protection system is thought to provide some benefit for additional protection and maximum life. Cathodic protection affects the portion of tank that is submerged; not above the water line. Our research indicated that consideration was given but no plans for such addition. Minor repairs and replacement should be provided from operating funds. For long term planning purposes, we recommend anticipating eventual replacement of tank in distant years as expense is very significant. When remaining useful life is within ten years or so of zero, tank should be professionally inspected and evaluated. There are engineering testing methodologies to determine wall thickness, strength, etc...

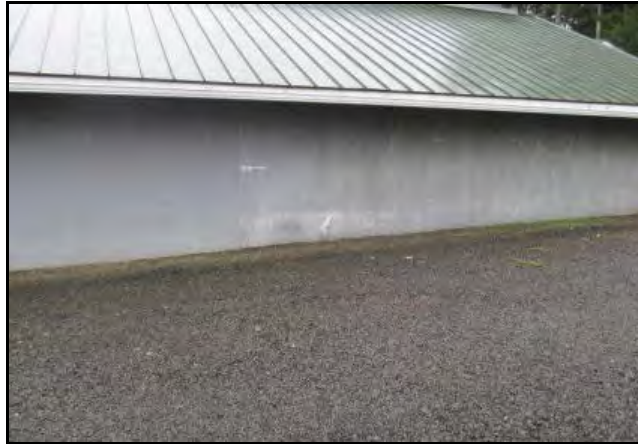
Comp # : 911 Storage Tank, Concrete - Replace Quantity: (1) 60,000 gallon

Evaluation : This two compartment, above-grade concrete tank contained within the Watershed was reportedly installed in the late 1960's / early 1970's. No significant spalling or obvious leaks were noted; just some minor local cracking and efflorescence. Interior of concrete tank is without any liner requiring renewal or replacement. Maintenance staff indicated regular inspections and cleaning with no problems known at this time. Our research suggests planning for typical service life of between 50-60 years for concrete tanks. Continue to monitor closely and perhaps have engineer evaluate when remaining useful life draws close to five years or if more cracking / spalling, leaks become prevalent. Note; some possibility of increased storage needs may exist for future years, as well as multitude of other design criteria - adjust in future reserve updates as conditions merit.

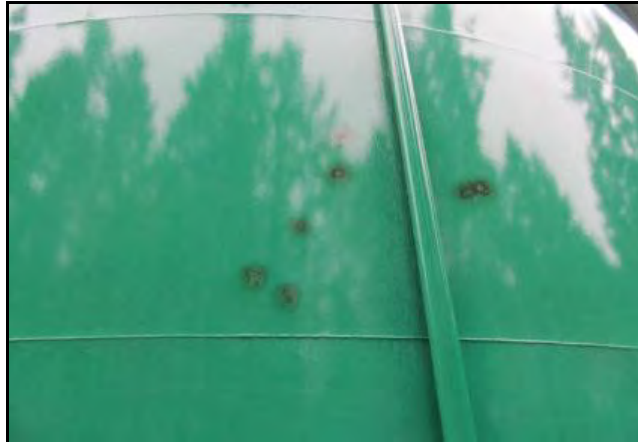
Evaluation : Raining when we inspected but exterior finish is faded and also had some local damage and corrosion due to vandalism. Refinishing projects are recommended for not only aesthetics but for protection of structure from weathering elements. Previous research with contractor that successfully completed 2012 interior coating projects recommended cycles of exterior cleaning, local corrosion mitigation and coating-over of exterior finishes at roughly 10 year intervals. No bids or plans for such to occur in FY 2015/2016 (as was previously recommended in our FY 2012/2013 Reserve Study). We recommend such a project occur in the near future and have factored below.

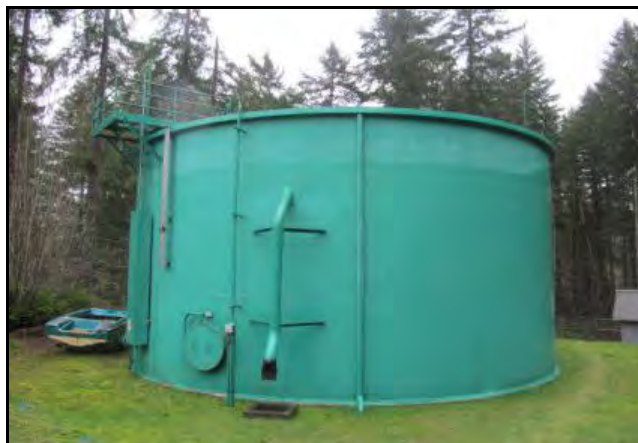
Evaluation : Image is representative; no image of interior available. Recent interior project is well documented. For purposes of long term planning anticipate refurbishing of interior coatings for steel reservoir at typical life expectancy of 15-20 years as projected below. Adjust in future reserve updates as conditions merit.

Useful Life:
20 years

Remaining Life:
17 years

Best Case: \$112,000

Lower estimate to blast / recoat

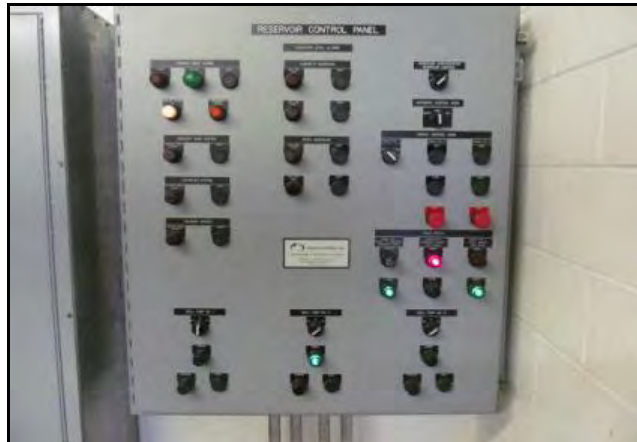
Comp # : 918 Reservoir Control System - Replace Quantity: (1) control panel

Useful Life:
30 years

Remaining Life:
20 years

Best Case: \$25,000

Worst Case: \$35,000

Lower estimate to replace

Higher estimate to replace

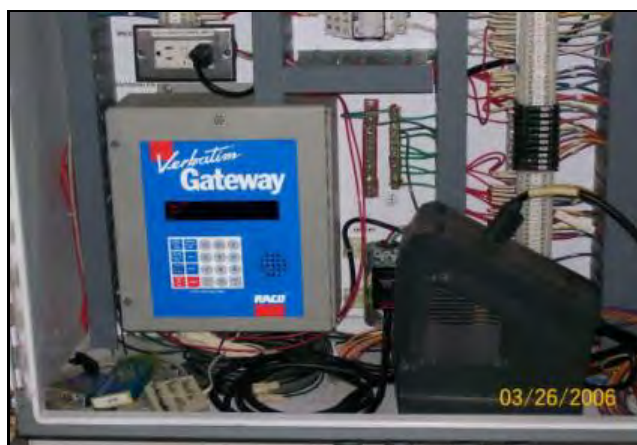
Comp # : 919 Telemetry System - Replace Quantity: (1) system

Evaluation : Basic telemetry in place was installed in 2005 and is for notification in the event of power failure, shut-down; some elements are part of reservoir control system panel (factored at previous Component #918). Additional expense for intervals of replacement of system dialer within this component assumes 10-15 year service life of system. When replacement is deemed appropriate, consider upgrade to SCADA system. Supervisory Control and Data Acquisition (SCADA) is a process control system that enables a site operator to monitor and control processes from remote location. A properly designed SCADA system saves time and money by eliminating the need for service personnel to visit each site for inspection, data collection/logging or make adjustments. Real-time monitoring, system modifications, troubleshooting, increased equipment life, automatic report generating . . . these are just a few of the benefits that come with today's SCADA system.

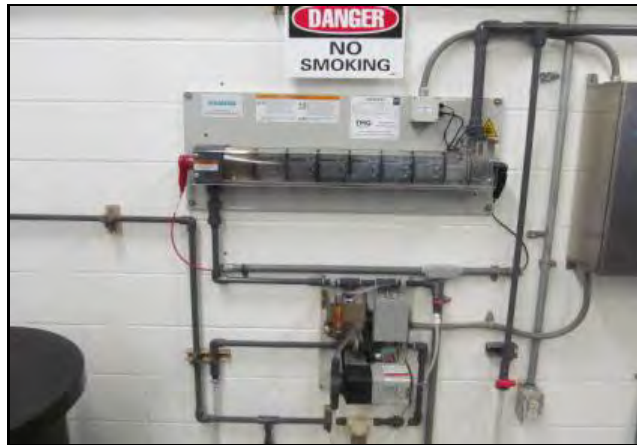
Comp # : 920 Hypochlorite Generator - Replace Quantity: (1) US Filter

Evaluation : No reported problems. System creates chlorine for disinfection and equipment was installed in 2005. Eventual replacement of system at typical service life based on our research is in the 25 to 30 year range (lined up with future cell replacement for long term planning purposes; cost of Component #922, cell replacement will need to be added to arrive at total project expense).

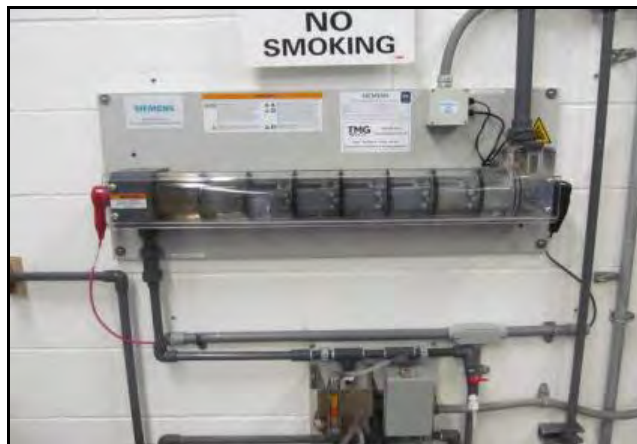
Comp # : 922 Hypochlorite Cells - Replace Quantity: (1) US Filter

Evaluation : Equipment upgrade to facilitate improved design / type in 2012 / 2013 at project expense of \$12,000. Research with contractor indicated that cell life (anode) is roughly seven- ten years with similar current replacement expense.

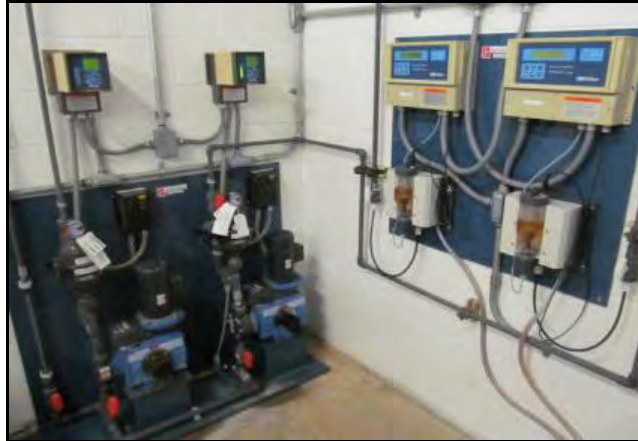
Comp # : 926 Treatment/Monitoring - Replace Quantity: Pumps, sensors, monitors

Evaluation : Equipment installed in 2005; no segregated expense provided. Reportedly systems are in fair operating condition at this time. This component factors a funding allowance for replacement around the 20 year mark of life.

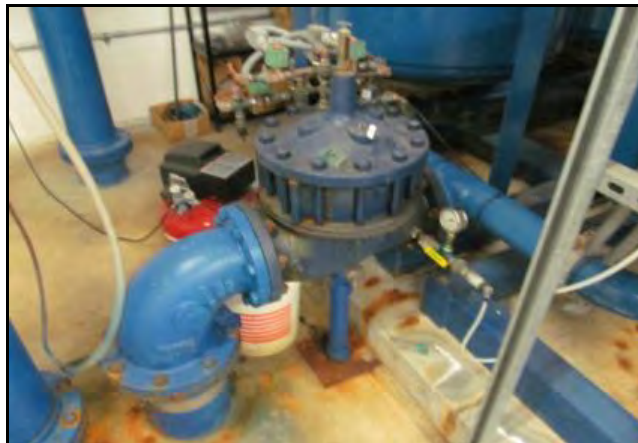
Comp # : 929 Cla-Val Valves - Replace Quantity: (2) flow control

Evaluation : One of two valves had solenoids replaced in 2012 (expense was \$1,200). Previous research with providing contractor (Gary @ GC Systems) indicated that expense to rebuild is well below current reserve funding threshold of \$3,000. Sustaining functionality from operating monies is assumed.

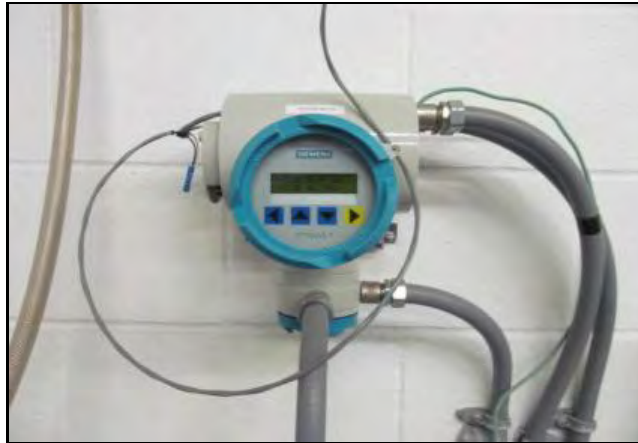
Comp # : 929 System Components, Small - Replace Quantity: Assorted systems

Evaluation : There are numerous small connections, meters, gauges, valve assemblies, etc... These ancillary water system components will need rebuilding or replacement from time to time but are expected to also be below the reserve funding threshold cost and therefore should be expensed as general maintenance from within the operating budget per occurrence.

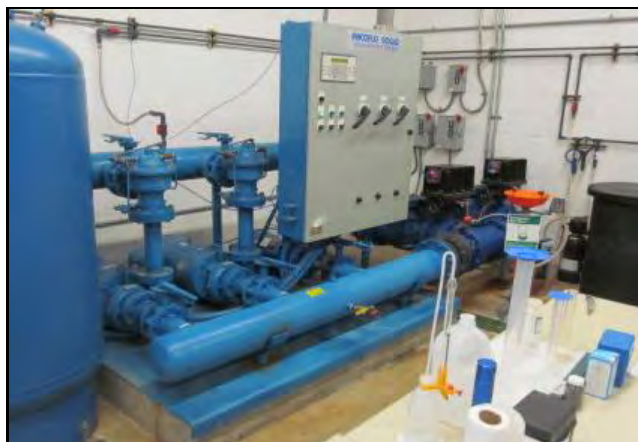
Comp # : 930 Booster System, Primary - Replace Quantity: (1) Paco 9000

Useful Life:
20 years

Remaining Life:
9 years

Best Case: \$95,000

Worst Case: \$115,000

Lower estimate to replace booster skid

Higher estimate to replace booster skid

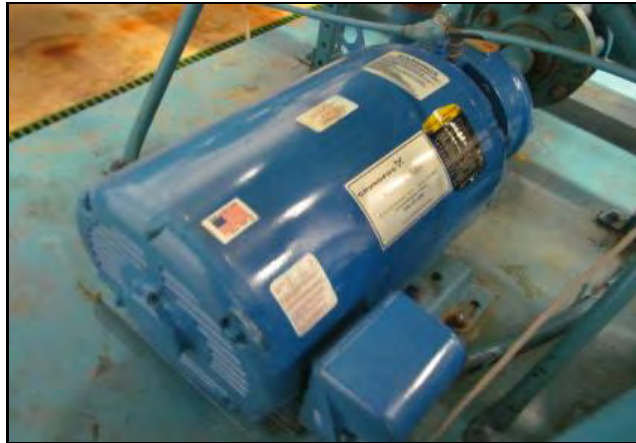
History : 2014 project to replace (1) pump, rebuild (1) pump at \$10,000 expense, 2012 expense of \$4,000

Evaluation : In addition to total replacement assumptions, a general allowance for more significant maintenance events is factored below. Examples of such are recent 2014 project to replace (1) pump and rebuild (1) pump at \$10,000 expense. Also, 2012 project to rebuild check valves / diaphragm repairs (\$4,000 including parts). Track needs / expense patterns carefully and adjust in future reserve updates.

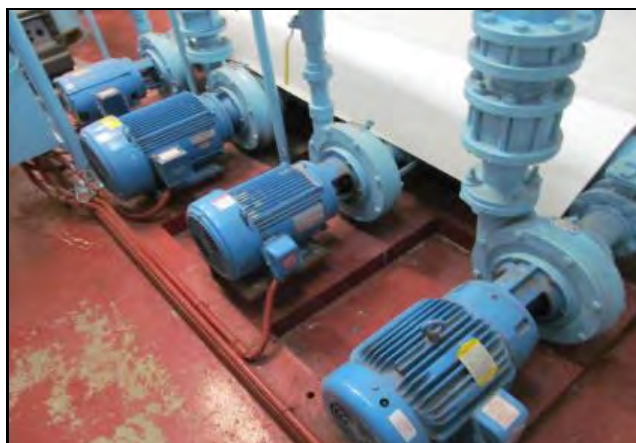
History : Installed in 1967; replacements of pumps in 1991

Evaluation : No reported problems. Older system installed in 1967 is still operational but now considered a reserve system. Previous history includes replacements of pumps in 1991 (7.5 HP and 15 HP, two each) - ongoing daily inspections, regular exercising and maintenance are indicated. Although it is our understanding that this system would not be entirely replaced if it failed, the community will likely continue maintaining viability until that time. Notwithstanding current status as a emergency back up, a general allowance for more significant maintenance events is prudent. Track needs / expense patterns carefully and adjust in future reserve updates.

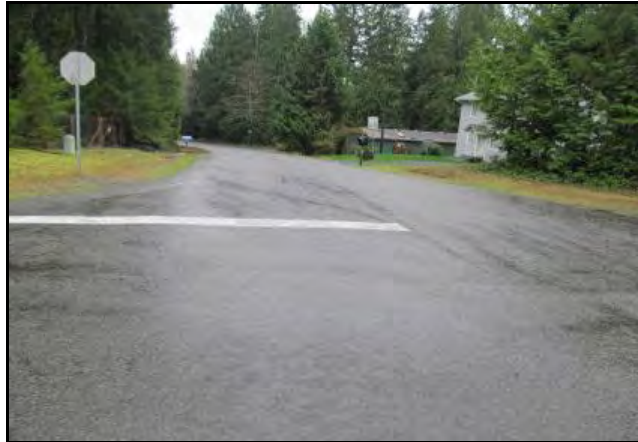
Comp # : 940 Water Main Line Project, B-Replace Quantity: Approx 2,600 LF

Evaluation : Main and distribution piping length totals approximately 13.5 miles (71,150 LF). A significant portion of this older water main / distribution piping had been recommended to be replaced in a phased manner as a result of previous analysis by CHS Engineers, LLC, Bellevue, Washington, provider of your last state required Water System Plan. Replacements were indicated primarily to improve flow and fire protection areas but also to replace leaking sections. See 2009 / 2010 WSP for supporting detail. 2015 / 2016 WSP plan is in progress as this report was written but will not be completed for months into the future. Note that much of the original PVC main line was 2"-6" with minor amount of 8" Asbestos Cement and 10" Ductile Iron. One of five phases of replacement has already been completed in 2009 at an expense of ~\$247,000 (2,600 LF along Eastlake Drive from E Timberlake Drive W to Timberlake Drive E). Included in projects are related connections, hydrants, asphalt repair, etc... Replacement mains for these targeted areas will likely consist of 8" Ductile Iron. Previous 2012 research indicated next phase of project would likely be completed in 2014; West Lakeshore Drive to Pickering Drive (2,600 LF). No such project has occurred; 2015 discussion with WSP representative indicated deferral until at least FY 2016 / 2017 is now anticipated (subject to completion of analysis for 2015 / 2016 WSP). Prudent planning suggests anticipating replacement projects at roughly the 40-60 year time frame as projected below. Note; photo is only representative and not indicative of phasing.

Useful Life:
60 years

Remaining Life:
1 years

Best Case: \$312,000

Worst Case: \$338,000

\$120/LF, lower estimate to replace mains

\$130/LF, higher estimate to replace mains

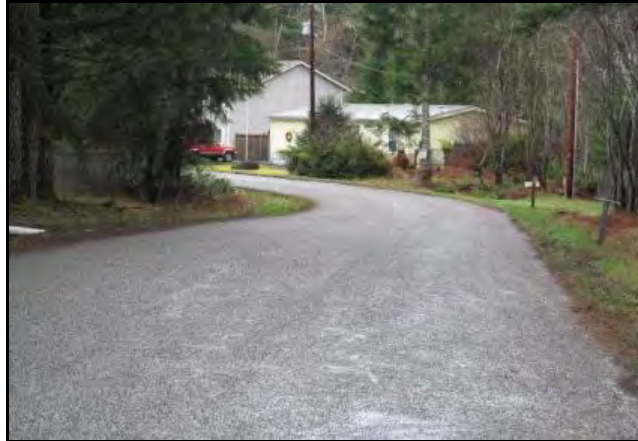
Comp # : 940 **Water Main Line Project, C-Replace** Quantity: Approx 2,000 LF

Useful Life:
60 years

Remaining Life:
2 years

Best Case: \$240,000

Worst Case: \$260,000

\$120/LF, lower estimate to replace mains

\$130/LF, higher estimate to replace mains

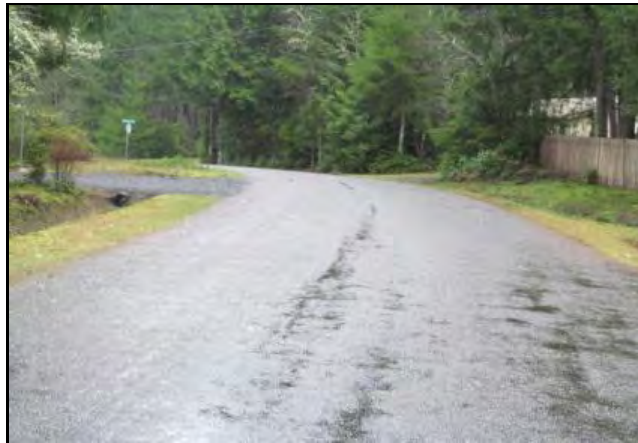
Comp # : 940 **Water Main Line Project, D-Replace** Quantity: Approx 2,400 LF

Useful Life:
20 years

Remaining Life:
5 years

Best Case: \$288,000

Worst Case: \$312,000

\$120/LF, lower estimate to replace mains

\$130/LF, higher estimate to replace mains

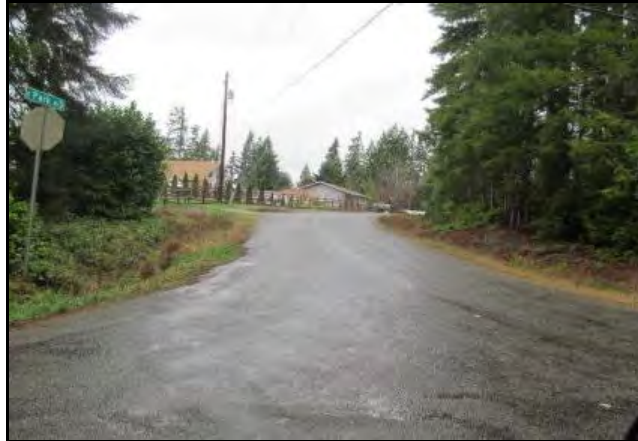
Comp # : 940 Water Main Line Project, E-Replace Quantity: Approx 2,800 LF

Useful Life:
60 years

Remaining Life:
8 years

Best Case: \$336,000

Worst Case: \$364,000

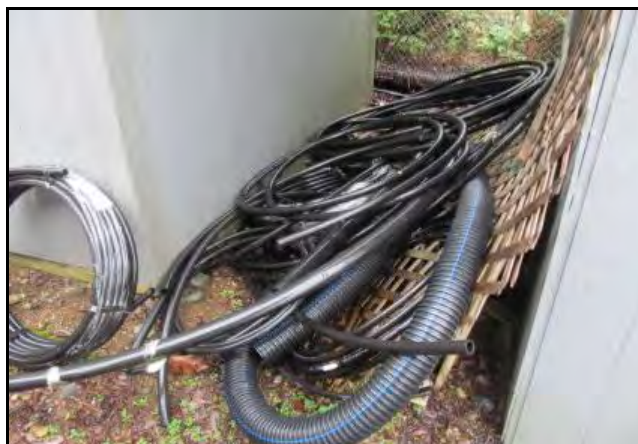
Comp # : 946 **Service Lines - Replace** Quantity: Extensive linear feet

Evaluation : Service lines off of the main water distribution lines are reportedly black plastic pipe of varying ages. These small 1' connecting lines are repaired / replaced as maintenance item. No basis for cyclical reserve funding at this time. Continue proactive leak detection, repair/replacement as needed using operating funds.

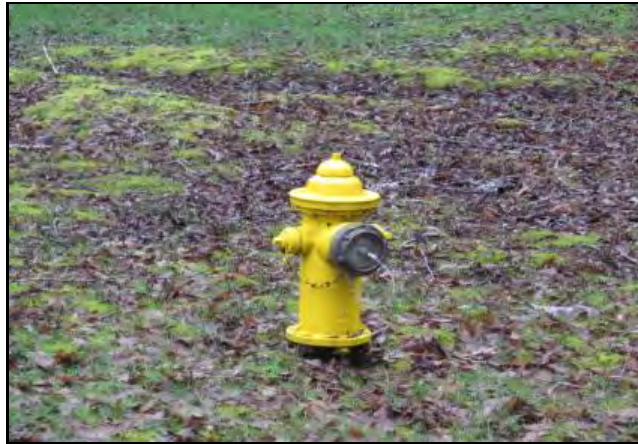
Comp # : 950 Hydrants - Add/Replace Quantity: (18) hydrants, existing

Evaluation : Other than issues regarding spacing and coverage, no reported problems. Age of existing (18) fire hydrants vary; (6) were reportedly added in 2009 phased water main project. Going forward, 2010 WSP assumed phased addition / expense of hydrants in conjunction with other phased water main replacement work (Components # 940, 941, 942 and 943) but also recommends additional (18) hydrants to increase fire protection along the other 6" mains that make up the major loops within the systems. 2010 WSP had recommended installation of two locations per year in each year, 2009-2017. None have been added so far and time frame below is only a budget placeholder until completion of 2015/2016 WSP. Since useful life of hydrants are typically long lived, maintenance to sustain is inexpensive and ages of installations will vary considerably we have only expressed replacements of these recommended (18) locations as a one-time project. Track needs and expense patterns closely in future reserve updates to form any basis if cyclical funding is appropriate.

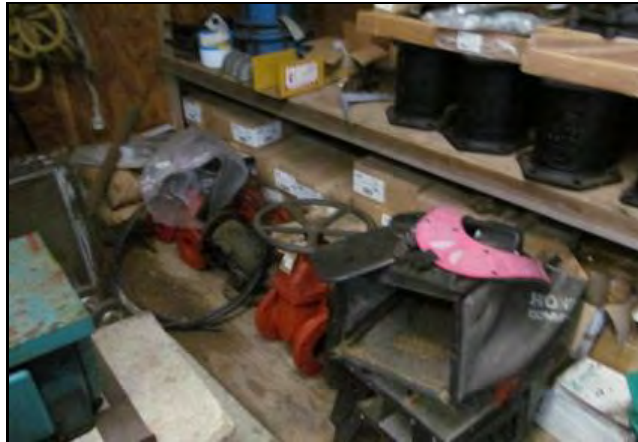
Comp # : 954 Blow-Out/Isolation Valves - Replace Quantity: (65) total, assorted

Evaluation : Roughly (40) isolation valves and (25) blow-out valves of varying ages and sizes are installed throughout community at present. Annual inspections, maintenance and individual replacements from operating budget were indicated. With this understanding, no reserve funding factored at this time.

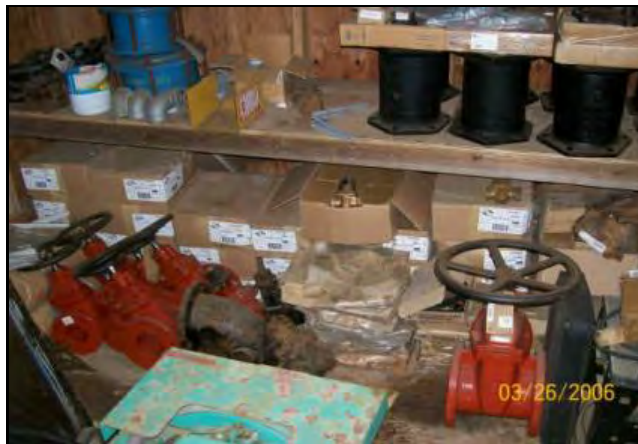
Comp # : 955 Pressure Reducing Valves - Replace Quantity: ~(570) Cash Acme EB86U

Evaluation : Roughly (500) PRV's were installed in previous years near service connections by maintenance staff. Those locations were primarily in the lower elevations with another ~(50-70) or so replacements available for remainder of service locations (parts already on shelf). For general planning purposes assume estimated useful life of PRV'S is between 20-25 years with future replacement expressed below as all-at-once project for ease of reporting. Document / track history of replacement and adjust in future reserve study updates as conditions merit.
